Assessment Programs for Aging Fiberglass USTs

Using remote video as a first step to determining the condition of your tanks and options for the future.

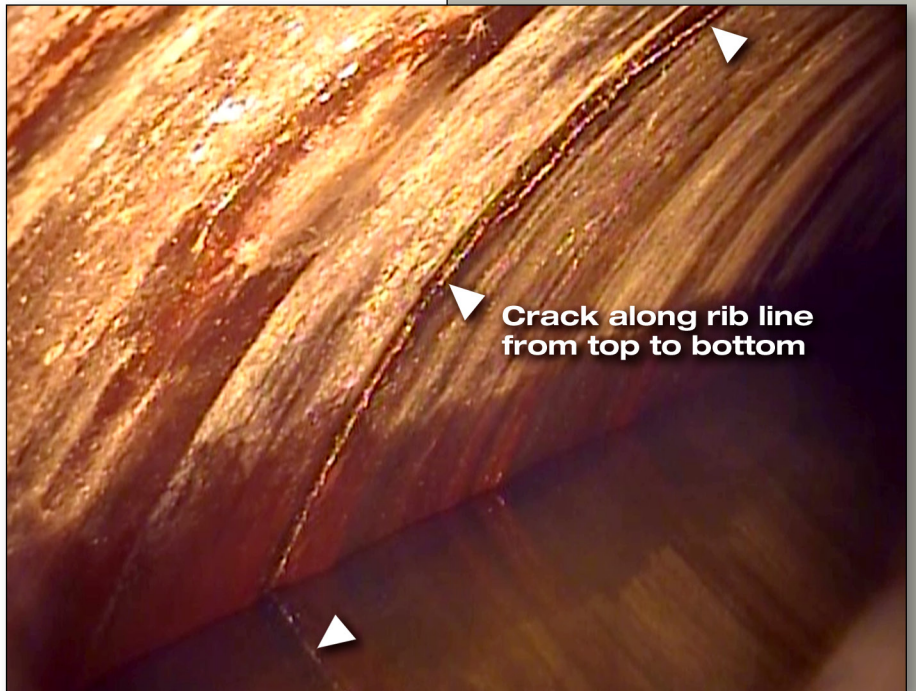
Crack along rib line from top to bottom

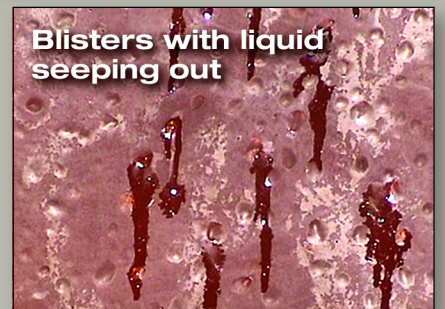
Blisters with liquid seeping out

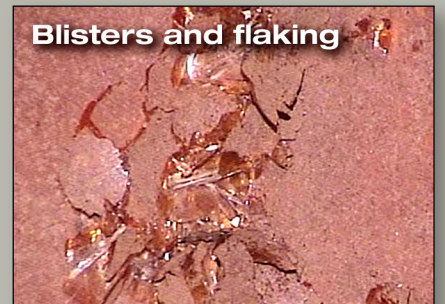
Blisters and flaking

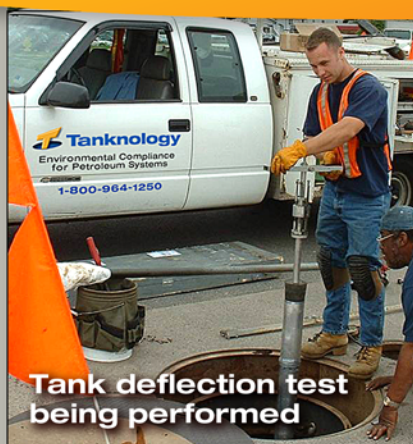
Tank deflection test
being performed

If the results of the TankCam Inspection indicate that a tank may have become deformed over time, we can also employ our **Tank Deflection and Deformation Testing** system to verify whether the roundness of the tank is within its specified tolerance.

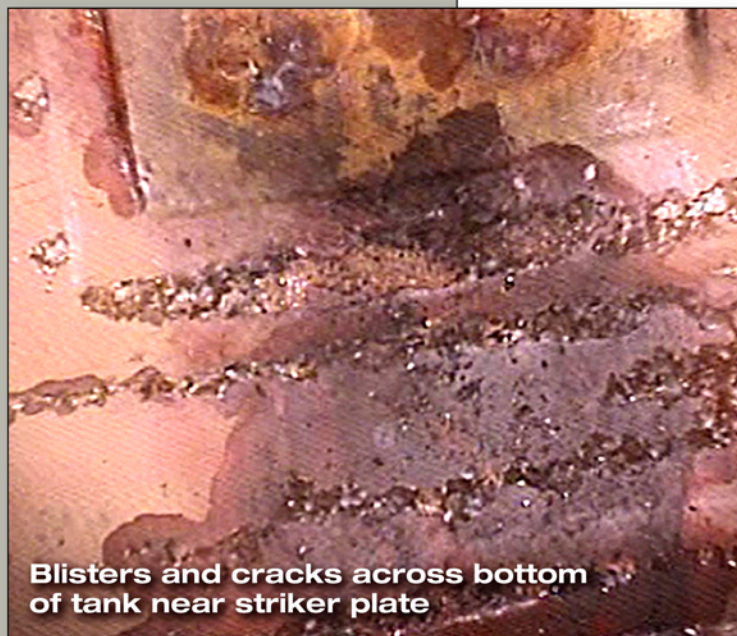
Blisters and cracks across bottom
of tank near striker plate

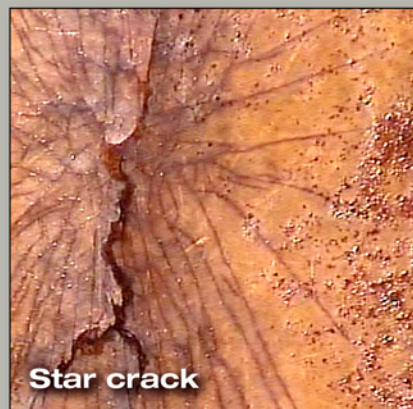
Star crack
